BUILDING A HURRICANE RESISTANT SLOPE IN DOWNTOWN HOUSTON

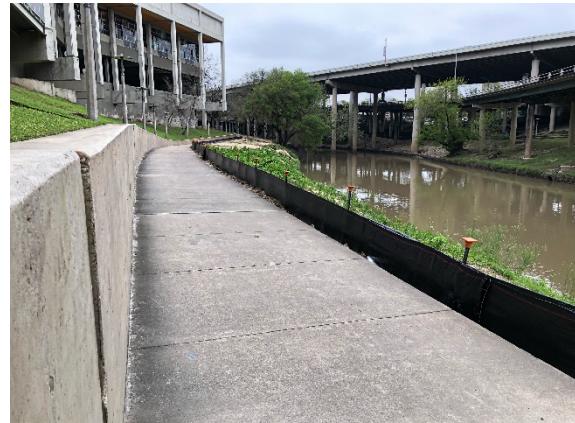
It was the flood water forces resulting from Hurricane Harvey that damaged both the hillside and building to the extent that the building needed to be closed. Four days of unrelenting downpour created an overwhelming amount of stormwater runoff that brought the rushing Bayou above the building's foundation line, allowing the turbulent water to chip away at the building's concrete base, as well as wash away layers upon layers of the hillside. As Harvey pulled away and the water receded, several large holes in the building wall became visible, meaning the entire underbelly of Bayou Place had been flooded and was now open to the elements. In addition, the once vegetated hillside below the building was decimated, leaving it vulnerable to erosion and now an unsightly section of Buffalo Bayou Walk. Houston First, the building's management company, would need to repair the damage to both the building's wall and the hillside.

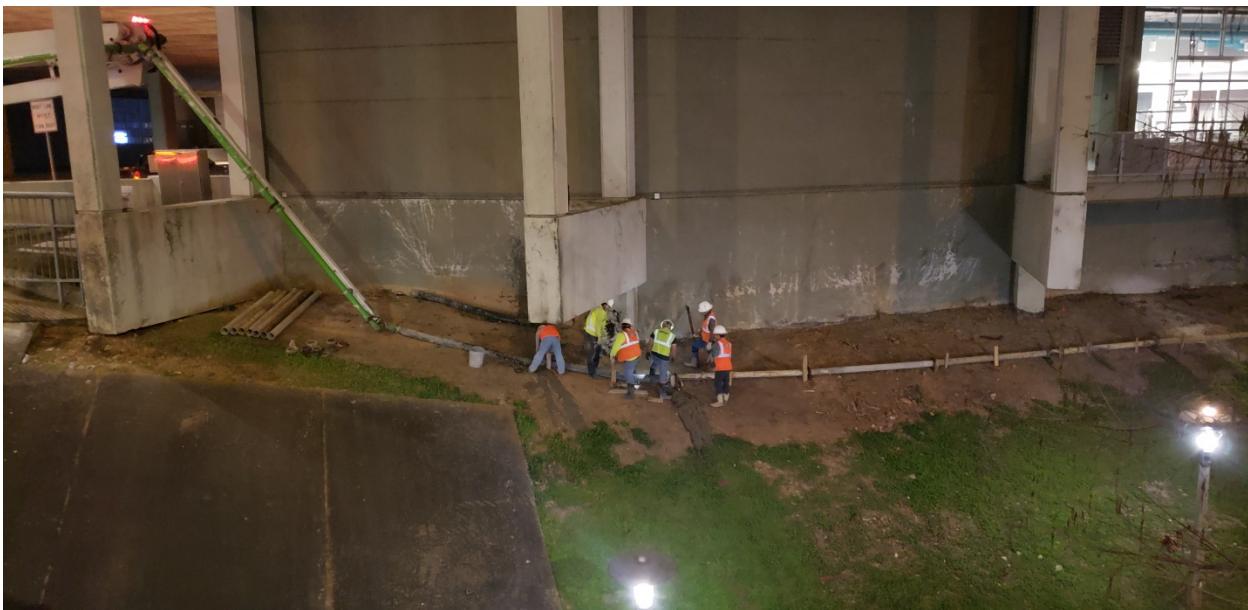
Understanding the force it took for the water to wash out the holes in the building's concrete wall, Construction EcoServices recommended laying Articulated Concrete Blocks from against the base of the building's wall, down the slope approximately 12 feet. This would be additional insurance for keeping the upper part of the hillside from washing away, even in the most turbulent flooding that may come. Further, while this section of the erosion control solution could be considered "hard armor", the type of blocks that were used have holes allowing vegetation to grow through, thereby eventually hiding the blocks under aesthetically pleasing cover.

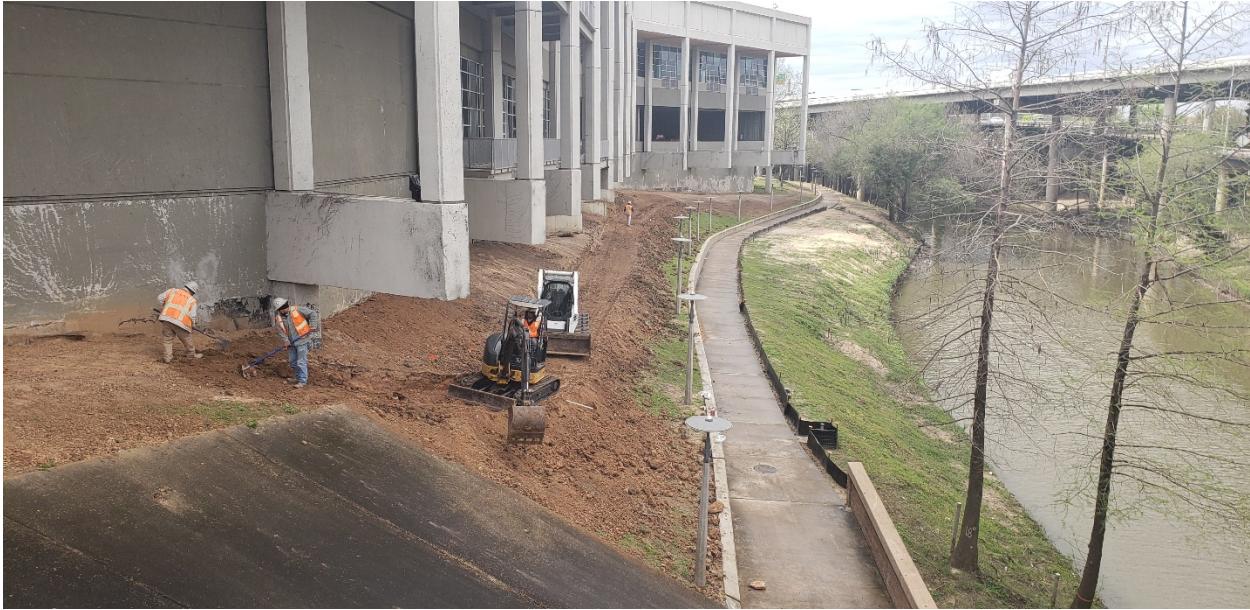
Again, the site location proved problematic. Being inaccessible to large vehicles or equipment, all materials, including three thousand Articulated Concrete Blocks, would need to be staged a quarter mile away and hauled in by small equipment or by hand down the walkway. Further, the three thousand blocks would need to then get up the hillside to be placed against the building. Taking into account potential damage to the hillside's existing irrigation system, as well as the additional time, effort and costs to do it, it was determined best to cut a temporary roadway into the hillside to allow a skid steer to drop off the pallets of blocks close to where the block's final resting places would be.

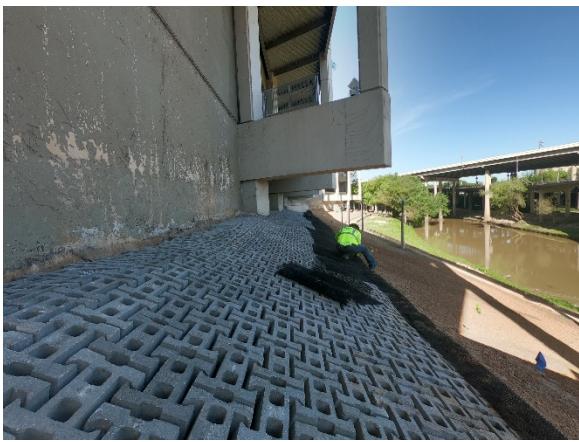
G-Tex Construction, experts in site work, excavation and grading, created the roadway and began hauling in the pallets of blocks. Starting at the far east end of the slope, each block was manually set into place, laid on top of Futerra® Turf Reinforcement Mat (TRM). The Futerra® 7020 mat was used under the blocks to keep the consistency of the TRM down the slope. Five days and three flatbed truckloads of blocks later, a solid 12x250' long section at the top of the slope was covered with the blocks, the temporary road filled in and the remaining slope grated and made ready for the next stage.

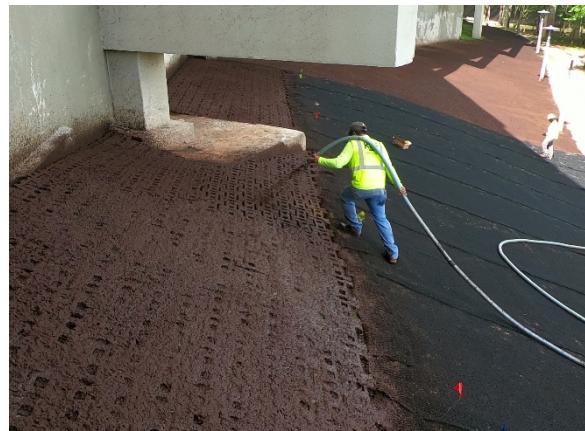
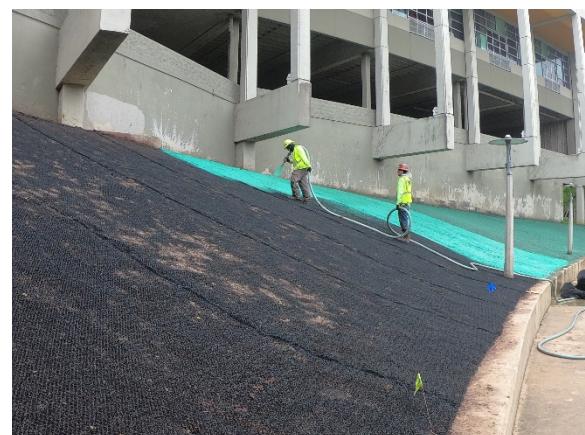
Using mallets and sod staples, K-4 Environmental workers manually secured the Futerra TRM to the entire remaining hillside below the blocks and readied the slope for the Flexterra

infilling. The mat was then infilled with Flexterra at a rate of 4,000 pounds per acre and included Bermuda seed.
